Residual-Strength Analysis of Primary Aircraft Structure Damaged Due to Projectile Impact and Penetration

Volume I Test and Analysis

GEORGIA INSTITUTE OF TECHNOLOGY
ATLANTA, GEORGIA 30332

FINAL REPORT FOR PERIOD NOVEMBER 1975 -FEBRUARY 1977

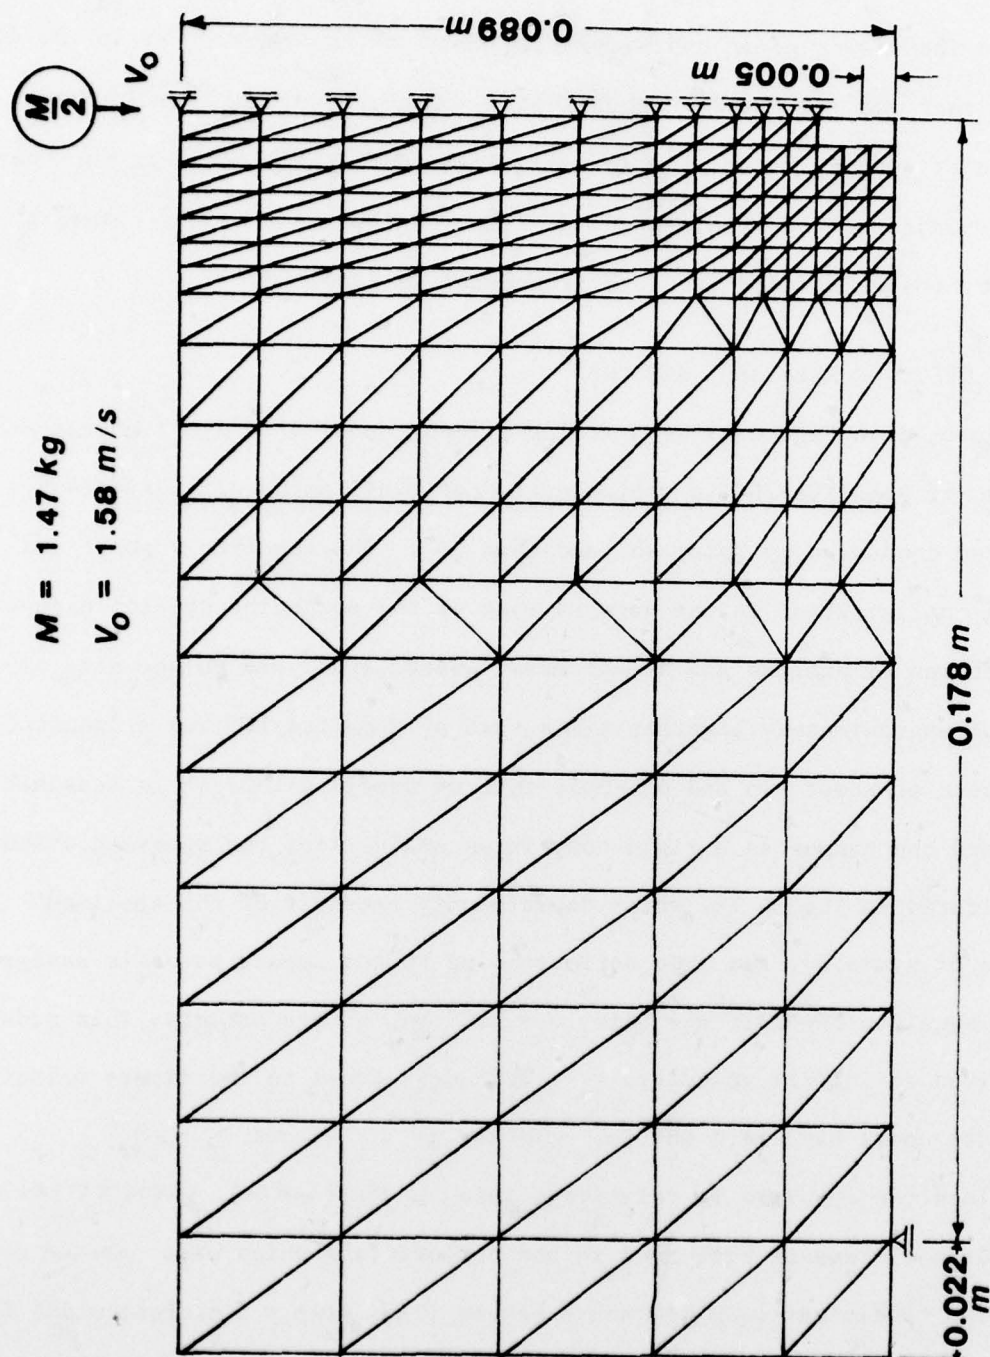
Figure 19. Finite-Element Model of the Kobayashi-Chan Dynamic Tear Test

Depicted in Figure 19 is a finite-element model of a dynamic-tear-test specimen of Homalite-100, a photoelastic material, with which experiments have been conducted by Kobayashi and Chan [4]. The specimen support and loading configuration is the same as that of the preceding section except for specimen dimensions and hammer mass. Since steel has an acoustic impedance of approximately eighteen times that of Homalite-100 and a longitudinal-wave speed of about two and one-half that of Homalite-100, it is reasonable to regard the hammer as a rigid body in an analysis of the specimen. Thus, as indicated in Figure 19, which depicts only one-half of the specimen because of symmetry, the node corresponding to the impact point is assigned a mass equal to one-half the mass, $M = 1.47$ kg, of the hammer. This node is then given an initial velocity, $v_0 = 1.58$ m/s, equal to the impact velocity; all other nodes have zero initial velocity.

Since the specimen is relatively thin (0.0095 meter), plane-stress forms of the elements were used in the computations which were carried out using the consistent-mass Newmark- β scheme (time step = 2 microseconds) for a crack length of 0.005 meter. The numerical results are given in Figure 20 where the stress-intensity factor and hammer acceleration are plotted for the

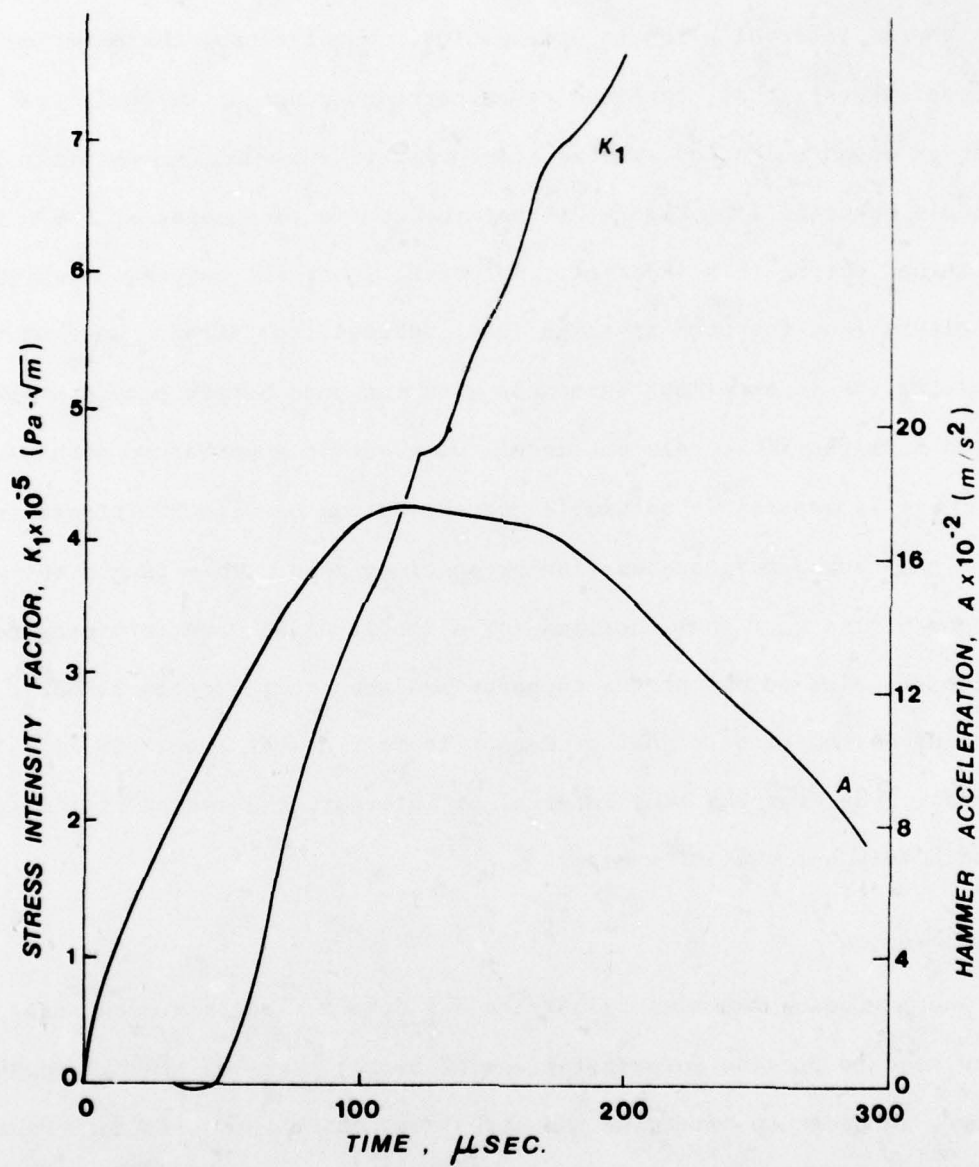
Figure 20. Computed K_I and Hammer Acceleration for a Dynamic Tear Test

first 200 microseconds following contact of the hammer with the specimen. The Kobayashi-Chan experiments were concerned primarily with the crack propagation phase of the motion, and they reported only limited data that bears on the interval prior to propagation. Nonetheless, the experimental evidence suggests that, for conditions corresponding to the analytical model, the crack began to extend at some time prior to 200 microseconds after impact. It should be noted from Figure 20 that the static toughness, $K_c = 606 \text{ kPa}\sqrt{\text{m}}$, is attained during this interval. Moreover, Kobayashi has communicated to the writers that the peak specimen load, deduced from strain gages on the hammer tup, is in excellent agreement with the peak hammer acceleration deduced from the finite-element model. Of greatest importance, perhaps, is that there is apparently no simple correspondence between the stress-intensity factor and the hammer acceleration or specimen load. This is not surprising in light of the fact that the time for a longitudinal wave to propagate from the impact point to one of the supports and then to the crack is about 185 microseconds (the first signal of impact is felt at the crack tip at 44 microseconds). Thus, for the time interval of interest, the motion of the specimen is definitely not that of a beam.
